# A LONGITUDINAL STUDY OF PLAYGROUND SURFACES TO EVALUATE ACCESSIBILITY

## Final Report

October 2013

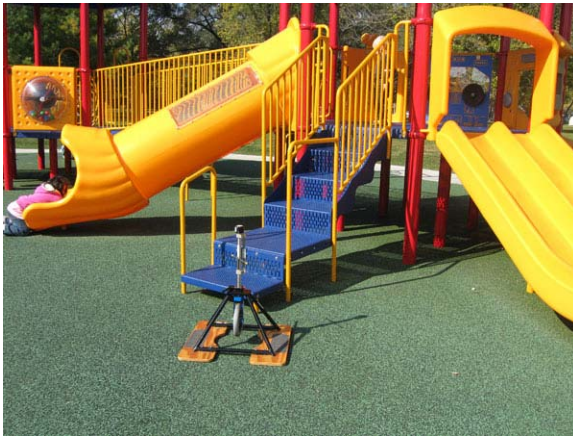
Photo 1: PIP at transfer system.

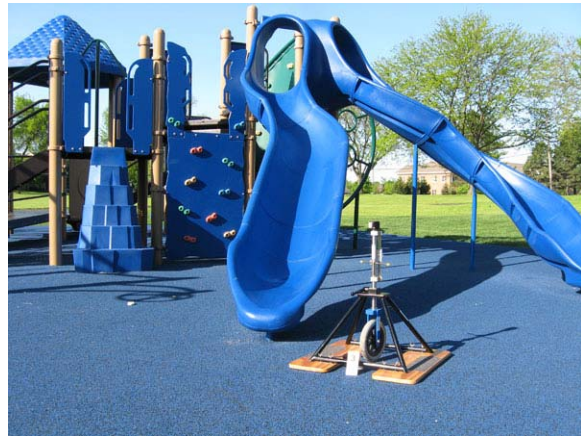
Photo 2: PIP with no recorded locations where the surface samples exceeded the accessibility standards.

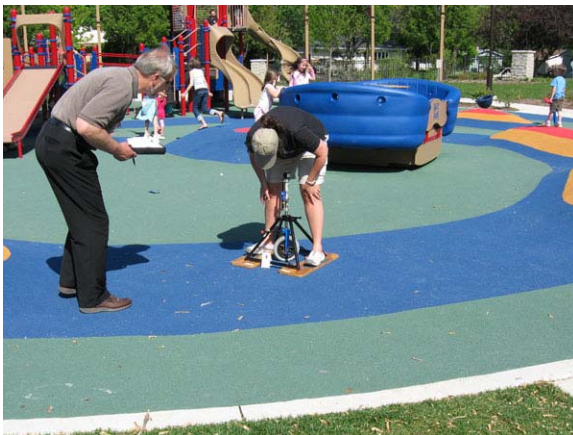
Photo 3: PIP location measured for firmness and stability using Rotational Penetrometer.

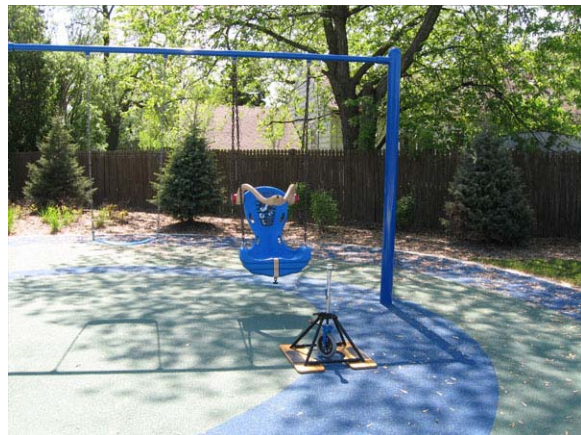
Photo 4: PIP location at swings found in non-compliance with HIC scores over 1,000.

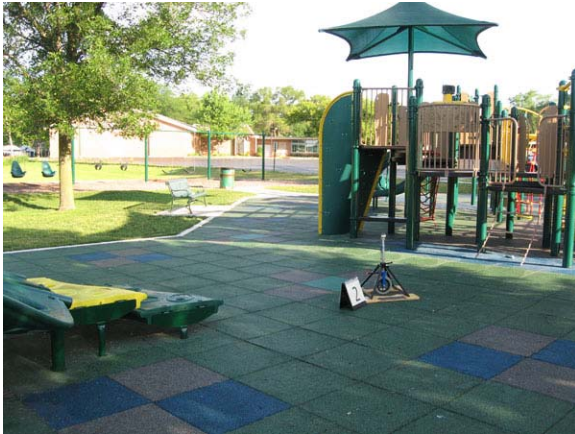
Photo 5: TIL on access route.

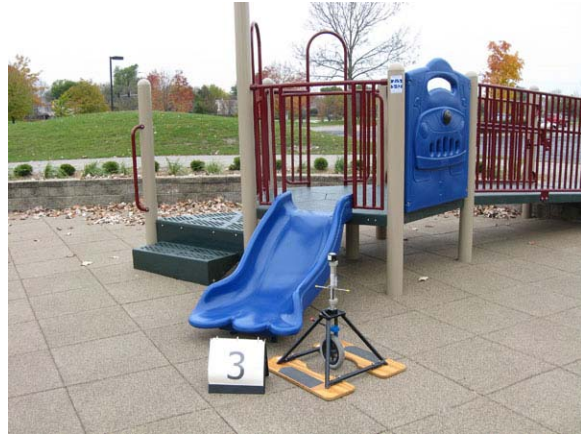
Photo 6: TIL at egress for slide.

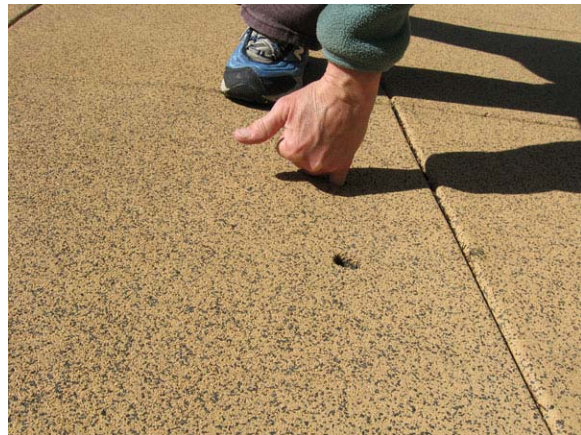
A greater number of TIL sites were recorded in need of maintenance than originally hypothesized. TIL deficiencies included punctures holes ranging from .50 inches to more than 2 inches in diameter; and instances where the seams had started to shift or buckle creating openings and changes in level along the accessible route. The playground owners reported mixed opinions on continued use of the TIL systems. The playground owner that had invested the most, both in material and staff training, had the highest number of surface deficiencies requiring maintenance. After five years of use, the playground owner decided to go with a different unitary surface system. Yet, a neighboring playground owner who had the surface installed by a contractor, only had to replace one tile during the study. The playground crew reported the replacement of the tile took two people less than an hour and it was relatively easy. The contrasting experiences of the two agencies could be as simple as products supplied by two different manufacturers.

Photo 8: TIL with puncture holes.

As noted in Table 3, the Mean SDS for TILs continued to increase each year of the study. The mean for the firmness and stability of the tiles tested in the sample was also under .50 inches, similar to the PIP. Throughout the period of the study, there were reoccurring instances where the TIL were assessed with punctures holes ranging from .50 inches to more than 2 inches in diameter and where the seams had started to shift or buckle creating openings and changes in level along the accessible route. It was unclear whether the puncture holes were products of intentional vandalism or unintentional damage from users stepping on rocks and other foreign objects with enough force to penetrate the surface. One playground owner went so far as to install signage at a site "No high heels" with the image of a woman's shoe. The maintenance staff was also able to replace the TIL with puncture holes following the site assessments.

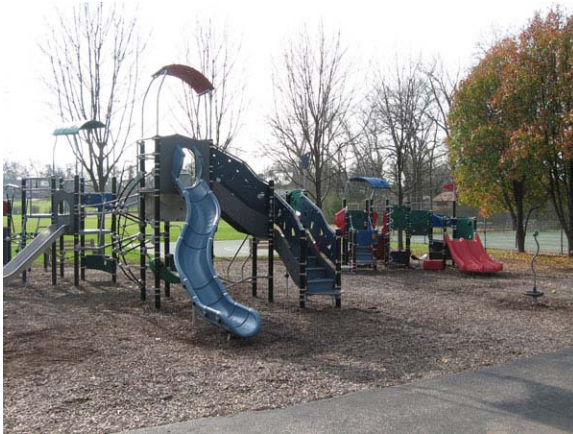
The playground sites in the sample with EWF experienced the greatest frequency of high SDS and mean for firmness and stability. Every playground installed with EWF was observed with undulation across the horizon of the surface area. The undulating surface material created changes in level, running and cross slopes exceeding the maximum allowable standards resulting in non-compliant accessible routes to play components. There was no observational difference in the issue of undulating surface between sites installed by maintenance personnel compared to sites installed by contractors. Review of installation data and discussions with staff indicated the loose fill surface installations did not follow the same procedures noted in the installation instruction by the surface manufacturer or in ASTM F1951-99 lab reports. EWF surface installations were mostly infilled, raked and leveled. A minimum amount of surface compaction was conducted, if any. This is a serious departure from the installation procedure

Photo 9: EWF noted with observed undulating surface.

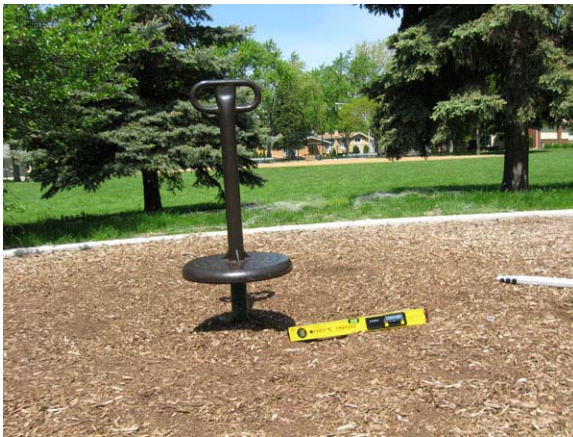
Photo 11: EWF with noted cross slope at ground level play component.

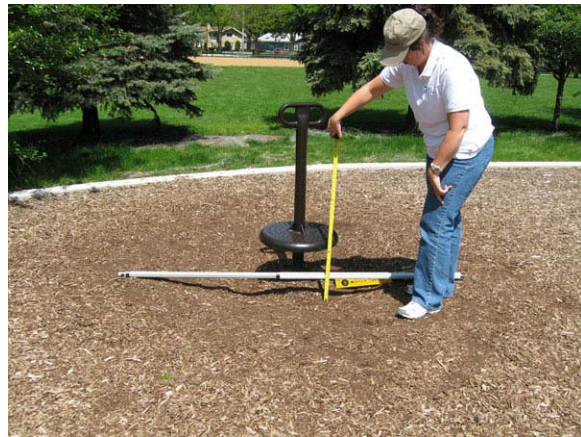
Photo 12: EWF with measurable displaced surface material at ground level play component.

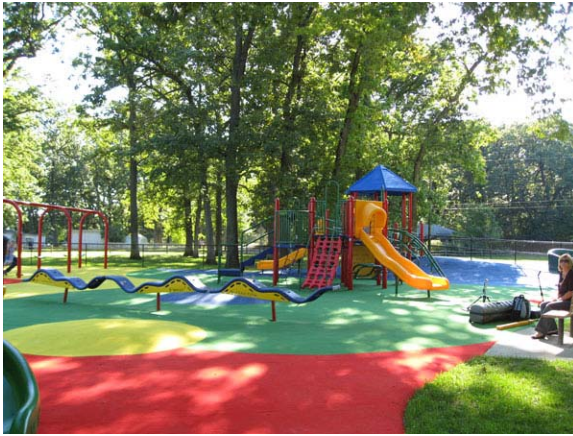
Photo 13: HYB surface system designed with outdoor carpet as top layer over engineered carpet pad base and infilled with silicone sand.

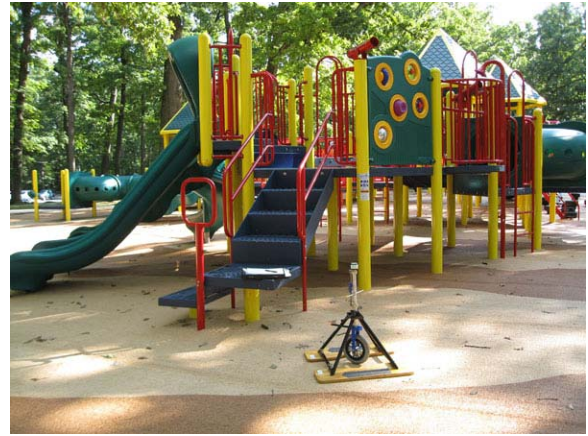
Photo 14: HYB surface system with rubber mat top layer over shredded rubber base contained in pillow forms.

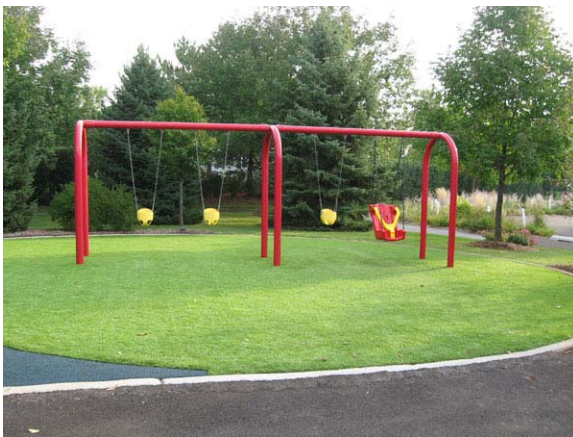
Photo 15: HYB turf grass surface system.
