PROPERTY CONDITION REPORT

ADA042822XYZ

REPORT OVERVIEW

Inspection Address: 141 South Dugger Ave., Roberta, GA 31078. The building faces southwest.

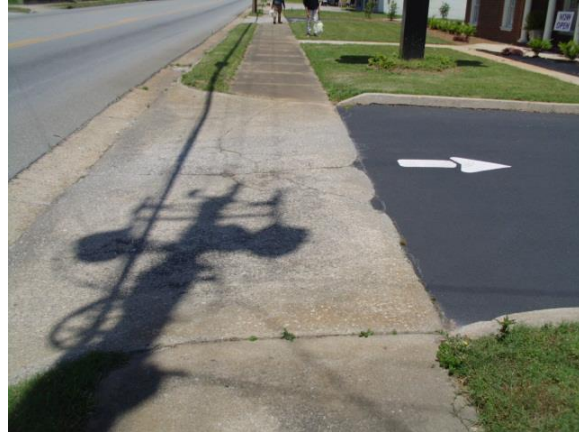
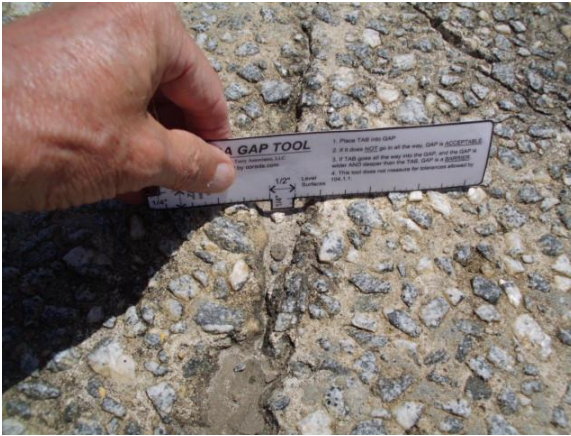
Item 2: The accessible municipal walkway that crosses the driveway in front of the facility has a damaged surface that has created excessive openings. See the photo on the right.

A close-up is shown on the left. 2010 ADA Standard 302.3, [Floor or Ground Surfaces] Openings, states, “Openings in floor or ground surfaces shall not allow passage of a sphere more than ½ inch (13 mm) diameter except as allowed in [Standards] 407.4.3, 409.4.3, 410.4, 810.5.3 and 810.10 [Not applicable]. Elongated openings shall be placed so that the long dimension is perpendicular to the dominant direction of travel.” This

RECOMMENDATION: Contact the municipality regarding repairs to this part of the walkway to level the surface.

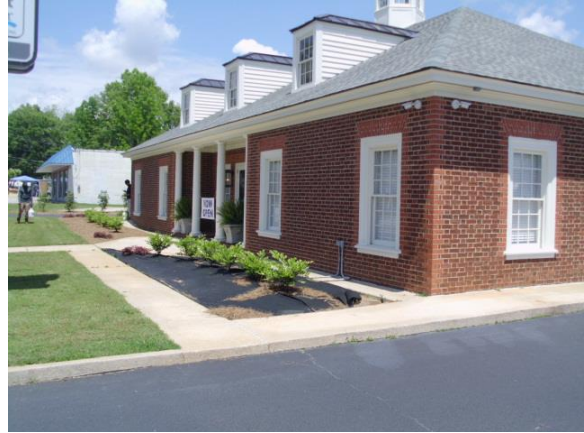
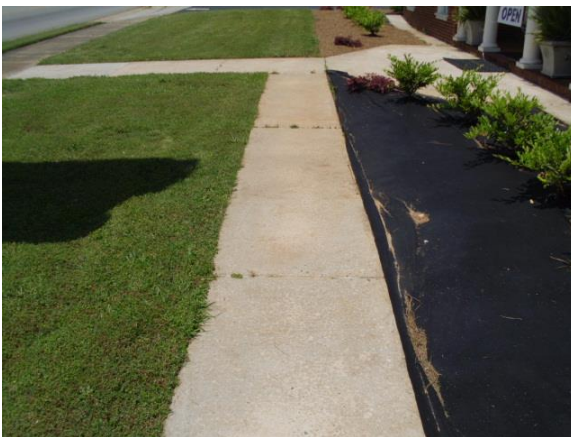
The walkway connecting the front walkway to the south side walkway is not 36 inches in width. In some locations this walkway is 35.5 inches in width. See the photo on the left.

RECOMMENDATION: Consider increasing route widths to 36 inches, where feasible, and reducing cross-slope to 2.08% or less. This is important for daily access under normal conditions and also for emergency egress.

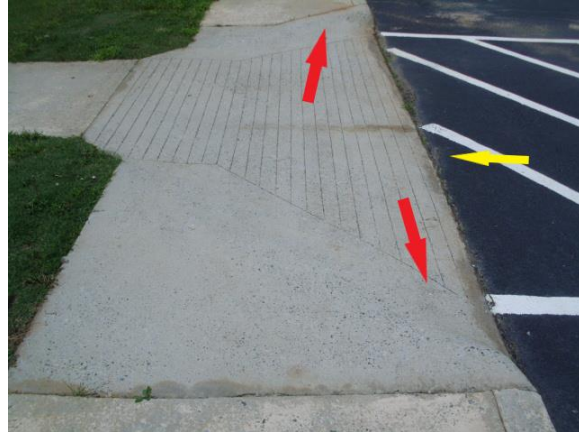
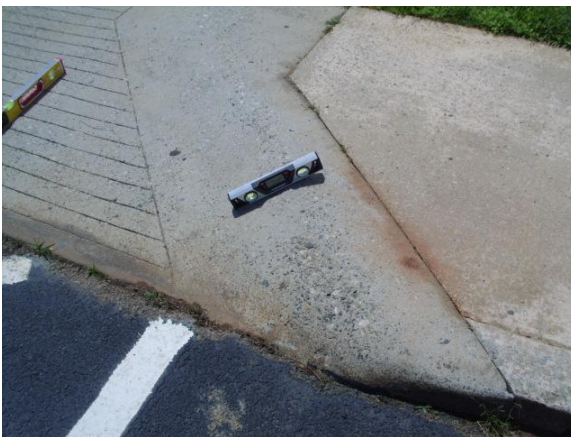
The curb ramp flares are sloped at significantly greater than 10%. The photo on the left indicates a slope of approximately 35%. The opposite flared side was sloped at approximately 17%.

RECOMMENDATION: If this curb ramp is to remain, the curb ramp and transition should be replaced or repaired to comply with the ADA Standards. See item 6 below for related information.

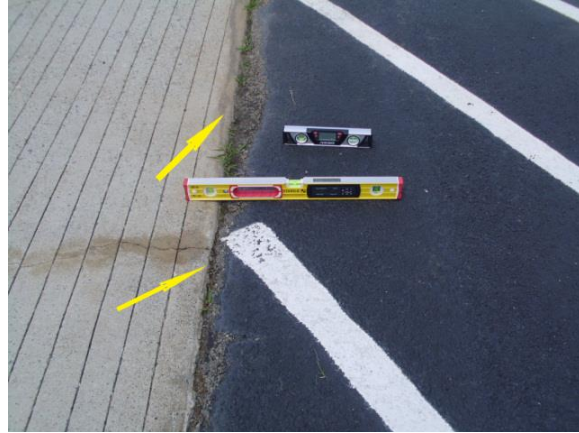
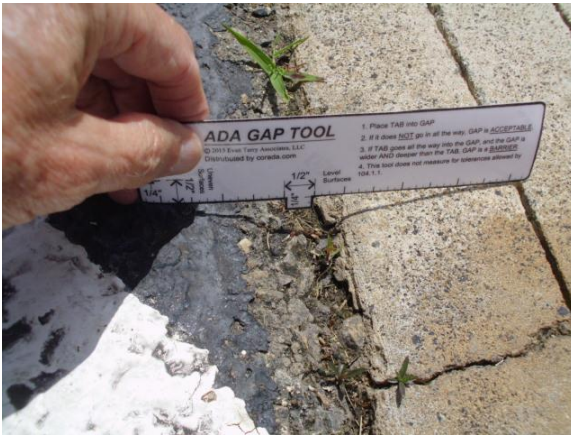
The photo on the right show the transition of the curb ramp concrete to the access aisle asphalt. This transition has deteriorated significantly and now has excessive openings and uneven elevations.

The photo on the left shows a closeup of the transition.

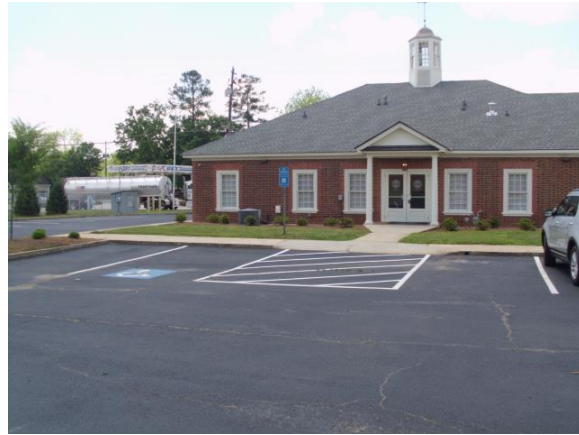
Item 6. There is only one marked ADA accessible parking space observed at the site and it is not the parking space located closest to the one public pedestrian exterior entrance. See the photo on the right.

There are approximately 28 non-ADA parking spaces and one (1) ADA accessible parking space observed behind the PSTC facility, for a total of 29 parking spaces.

2010 ADA Standard 208.3.1, [Parking Spaces, Location] General, states, "Parking spaces complying with [Standard] 502 that serve a particular building or facility shall be located on the shortest accessible route from parking to an entrance complying with [Standard] 206.4. Where parking serves more than one accessible entrance, parking spaces complying with [Standard] 502 shall be dispersed and located on the shortest accessible route to the accessible entrances. In parking facilities that do not serve a particular building or facility, parking spaces complying with [Standard] 502 shall be located on the shortest accessible route to an accessible pedestrian entrance of the parking facility." In other words, this facility needs two ADA accessible parking spaces, one must be van-accessible, and both should be at the closest location possible to this entrance.

RECOMMENDATION: Relocate the current van-accessible parking space and access aisle to the closest space available to the customer entrance at the rear of the building, and add one more ADA accessible parking space. These two accessible parking spaces can share the same aisle. This location will likely require a new curb ramp. Note that the current location of the accessible parking and curb ramp directs disabled individuals to the double doors that lead into the new employee work area and office space, which is not the intended public accessible entrance. This current installation can result in confusion and backtracking from this unintended entrance to the intended public access at the automatic door.

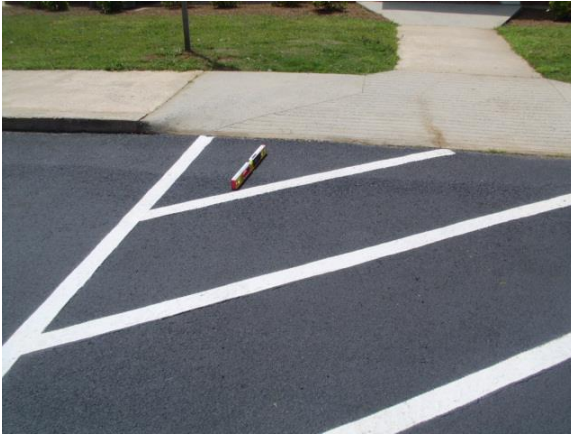
The slope of the parking space and access aisle is approximately 3.0% near the front of these spaces. The photo on the left is representative.

RECOMMENDATION: See items 5 and 6 above. There are several issues with this parking space, access aisle, and curb cut. If these spaces are to be abandoned there is no need to alter them. However, this slope issue will probably exist at other parking spaces along this walkway and will need to be addressed eventually. Repair as required.

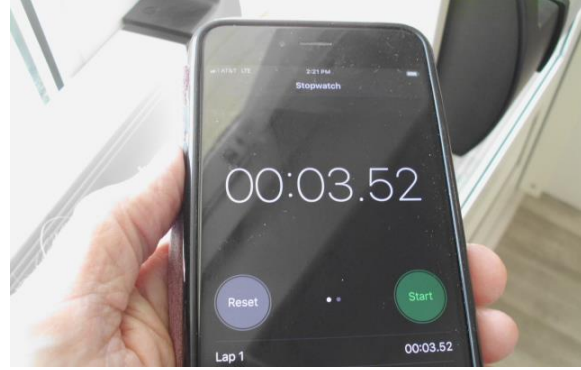
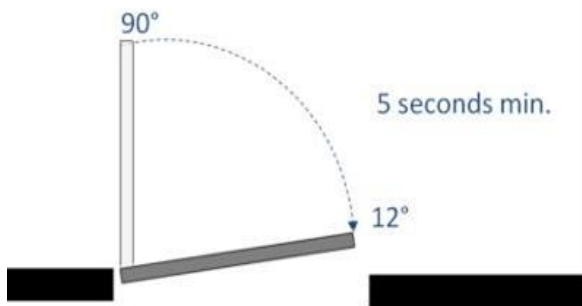
Item 10. Both the front and rear pedestrian entry/exit double doors have automatic closers that allow the doors to close too quickly and, floor mats that have deteriorated and warped edges. The photo on the right is representative of the quick closure rate.

RECOMMENDATION: Repair, adjust or replace the door closers and replace these mats with devices that comply with the ADA Standards. Worn, damaged or warped edges create tripping hazards. These mats are not carpet and therefore do not have to be fastened to floor surfaces and have trim on the entire length of the exposed edge; however, they do provide the service of keeping the floor from being wet (slippery) and should be maintained in good working order and not have worn, damaged or warped edges.

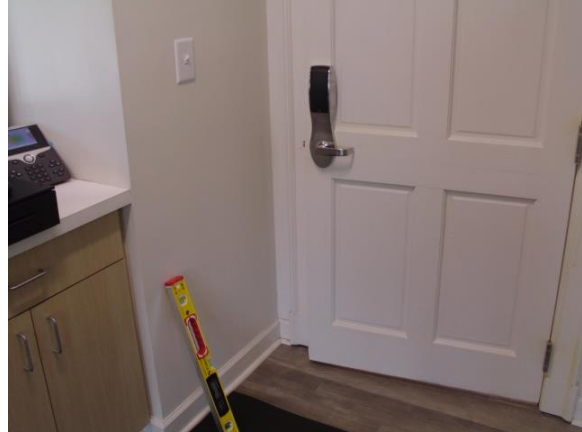
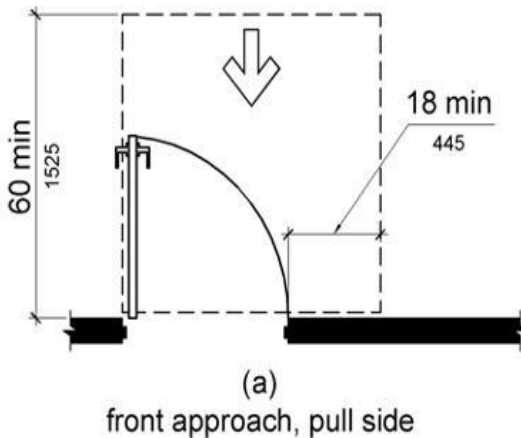
Item 14. The interior door for the employee work area on the north end of the facility does not have adequate maneuvering space on the pull side of the door. See the photo on the right. This door is pulled to open from the employee work area. This door has inadequate maneuvering space from the side shown in the photo.

RECOMMENDATION: Alter this door installation so that maneuvering space is provided.

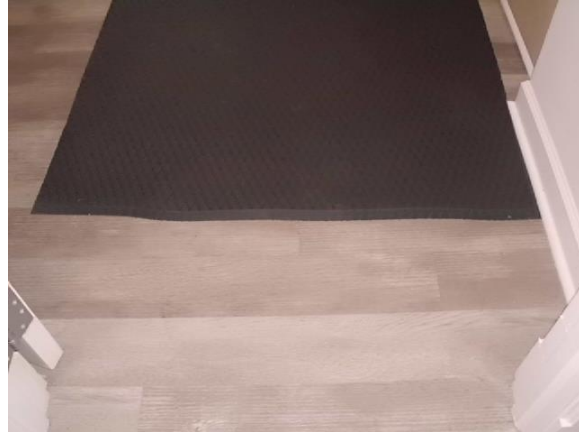
Although floor mats are not carpet and these floor mats are not fixed elements, these installations may present tripping hazards because of the excessive change in elevation and the loose edges. These mats may significantly increase the amount of force (roll resistance) needed to propel a wheelchair over a surface.

RECOMMENDATION: Replace these mats with a model that has more secure edges and no greater than $\frac{1}{2}$ inch abrupt change of vertical elevation. The principles of carpet for ADA compliance limits the height of these installations to $\frac{1}{2}$ inch and recommends secured edges.

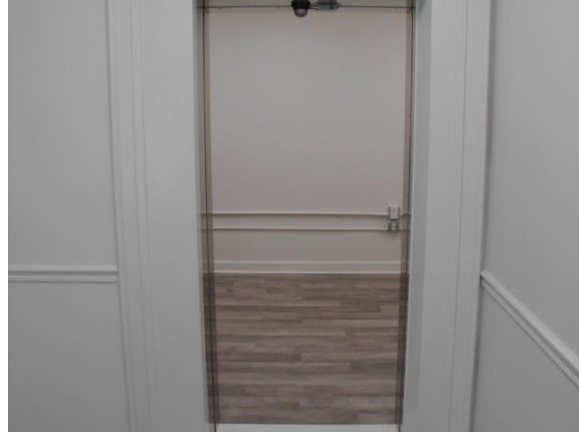
Item 19. Two vault door openings were observed with less than 80 inches vertical clearance and vault door thresholds too high above the finished floor. The photo on the right is representative where the height above the finished floor is approximately 78 inches to an object.

RECOMMENDATION: The doors for these vaults have been removed. There is no need for the thresholds. If possible, remove the thresholds and the objects at the top of the door openings to maximize door opening space and remove the tripping hazards associated with the thresholds.

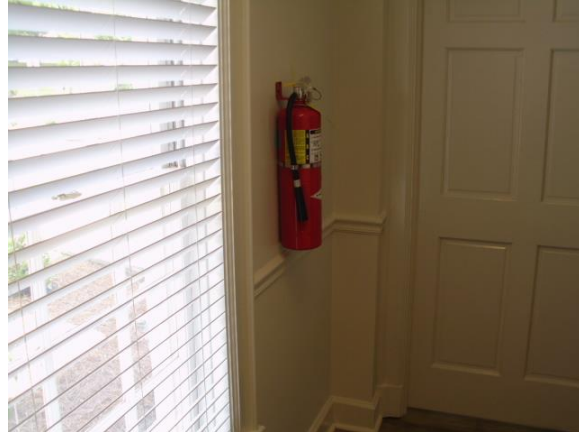
Item 20. A protruding object [fire extinguisher] was observed in the hall for the two toilet rooms on the first floor. See the photo on the right.

RECOMMENDATION: Re-locate the fire extinguisher or install in an alcove.

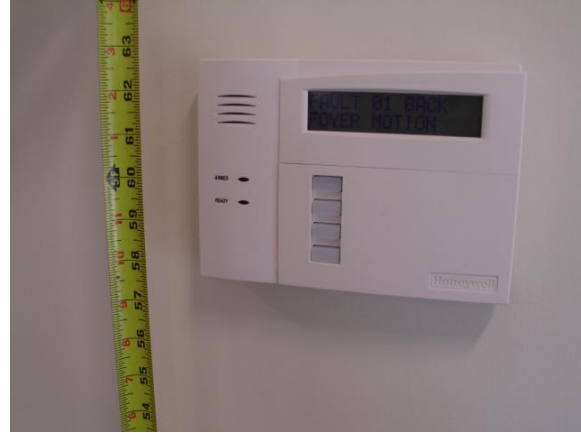
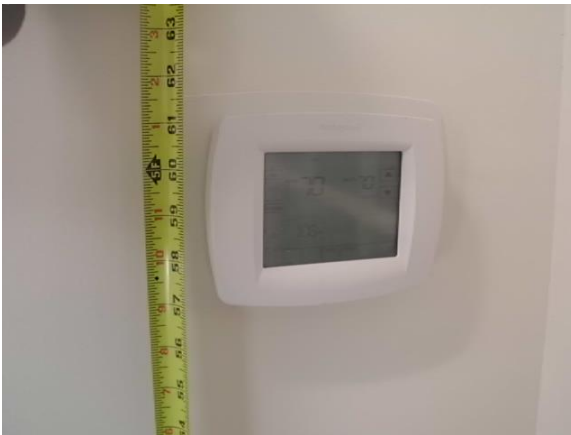
The photo on the left is a thermostat that is mounted too high above the finished floor.

RECOMMENDATION: Relocate these wall mounted elements to comply with the high side reach and low side reach standards and, if possible, maintain a clear space at each element. This includes the toilet rooms.

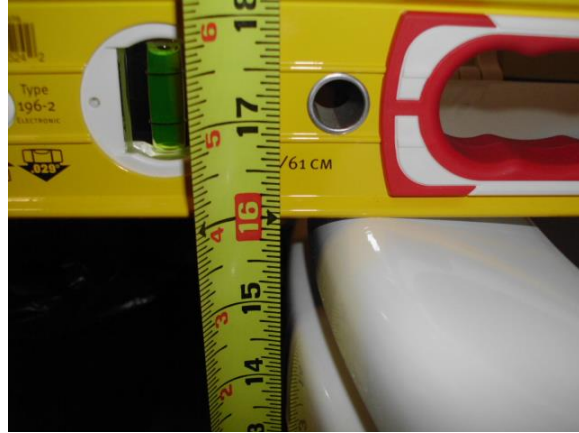
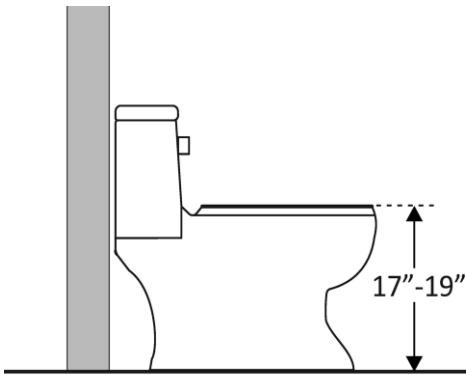
Item 30. The toilet seat height is too low to the floor and no toilet paper dispenser was observed. See the photo on the right of the toilet seat height.

RECOMMENDATION: Replace or alter the toilet installation to raise the toilet seat height and install a toilet paper dispenser.

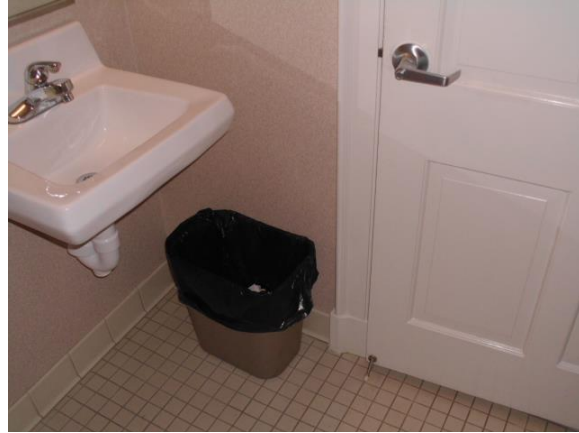
Item 32. In both toilet rooms there is inadequate door maneuvering space due to the proximity of the sink and trash can to the entry/exit doors. The photo on the right is representative.

In both toilet rooms the entry/exit doors open to the inside of the toilet rooms.

RECOMMENDATION: Relocate the trash cans and consider increasing the space in these toilet rooms to create the door maneuvering space, or consider combining both toilet rooms into one unisex toilet room.
