PROPERTY CONDITION REPORT

ADA042822XYZ

REPORT OVERVIEW

Inspection Address: 141 South Dugger Ave., Roberta, GA 31078. The building faces southwest.

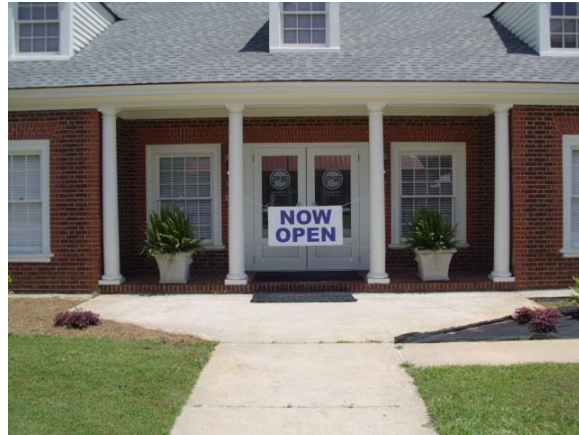
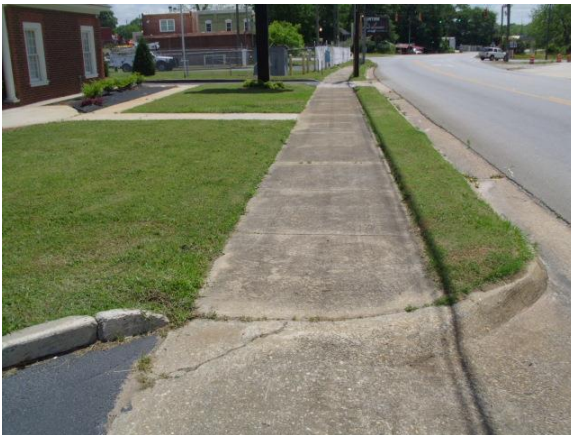
There are two site arrival points at the facility. These include the municipal walkway and the site parking lot. The intended accessible public entrance is at the rear of the facility where an automated door is installed. See the photo on the right for the front entrance. Note that the “Now Open” sign blocks access to the front entrance, but there is no sign indicating where an accessible entrance is located.

Item 1. There is no signage at the municipal walkway directing disabled individuals to the intended public accessible rear entrance.

The photo on the left is the walkway that connects the municipal walkway along South Dugger Avenue to the accessible walkway at the facility that leads to the front entrance.

RECOMMENDATION: To avoid confusion and possible back-tracking from the front of the facility, place a sign at this front walkway connection shown in the photo above pointing to the accessible parking and the intended public accessible entrance at the rear of the facility. The graphic below is representative.

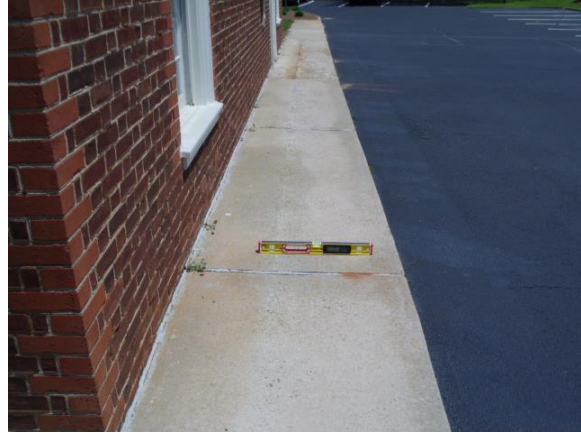
The walkway connecting the front walkway to the south side walkway is not 36 inches in width. In some locations this walkway is 35.5 inches in width. See the photo on the left.

The walkway that runs along the south side of the facility has a cross-slope greater than 5% away from the building. See the photo on the right. This is particularly significant in this location due to the immediate proximity of the vehicular way adjacent to this walkway.

RECOMMENDATION: Consider increasing route widths to 36 inches, where feasible, and reducing cross-slope to 2.08% or less. This is important for daily access under normal conditions and also for emergency egress.

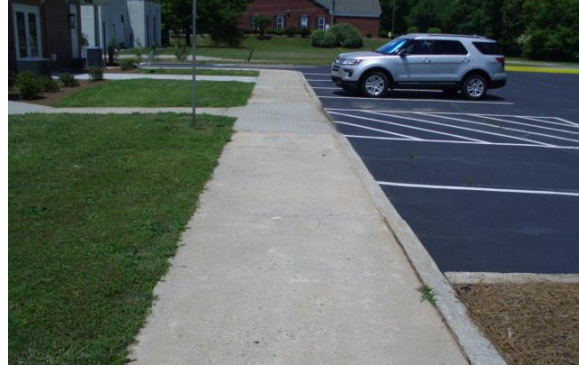
Item 4. The walkway across the rear of the facility and along the side of the parking lot has a cross-slope exceeding 2.08% and there are no vehicle wheel stops at the parking spaces. See the photo on the right.

RECOMMENDATION: Consider reducing the walkway cross-slope to 2.08% or less and install wheel stops at all parking spaces along this walkway. This is important for daily access under normal conditions and also for emergency egress.

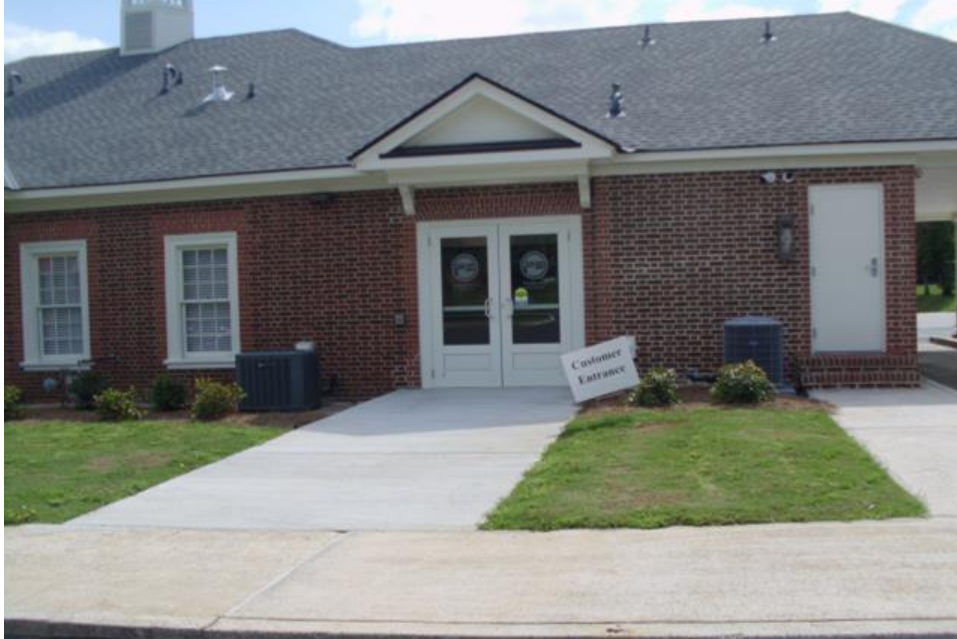
Item 6. There is only one marked ADA accessible parking space observed at the site and it is not the parking space located closest to the one public pedestrian exterior entrance. See the photo on the right.

Employees stated that the public pedestrian exterior entrance is the automated door at the rear of the facility that is second from the right when looking at the rear of the building. See the photo below for the entrance with a sign stating "Customer Entrance".

2010 ADA Standard 208.3.1, [Parking Spaces, Location] General, states, "Parking spaces complying with [Standard] 502 that serve a particular building or facility shall be located on the shortest accessible route from parking to an entrance complying with [Standard] 206.4. Where parking serves more than one accessible entrance, parking spaces complying with [Standard] 502 shall be dispersed and located on the shortest accessible route to the accessible entrances. In parking facilities that do not serve a particular building or facility, parking spaces complying with [Standard] 502 shall be located on the shortest accessible route to an accessible pedestrian entrance of the parking facility." In other words, this facility needs two ADA accessible parking spaces, one must be van-accessible, and both should be at the closest location possible to this entrance.

RECOMMENDATION: Relocate the current van-accessible parking space and access aisle to the closest space available to the customer entrance at the rear of the building, and add one more ADA accessible parking space. These two accessible parking spaces can share the same aisle. This location will likely require a new curb ramp. Note that the current location of the accessible parking and curb ramp directs disabled individuals to the double doors that lead into the new employee work area and office space, which is not the intended public accessible entrance. This current installation can result in confusion and backtracking from this unintended entrance to the intended public access at the automatic door.

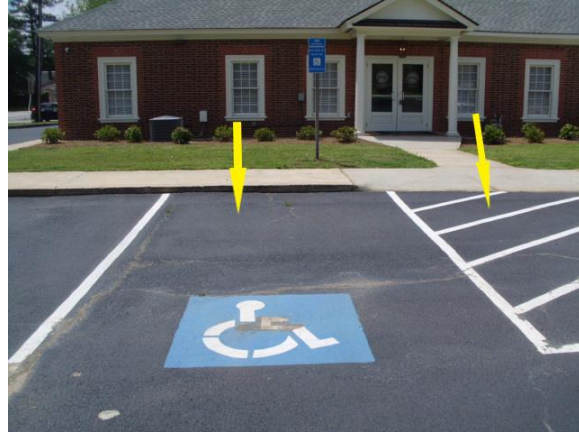
Item 7. The slope of the ADA accessible parking space and access aisle is too steep in the front of these spaces near the adjacent walkway. See the photo on the right.

2010 ADA Standard 502.4 [Parking Spaces] Floor or Ground Surfaces, states, "Parking spaces and access aisles serving them shall comply with [Standard] 302. Access aisles shall be at the same level as the parking spaces they serve. Changes in level are not permitted. EXCEPTION: Slopes not steeper than 1:48 [2.08%] shall be permitted." Advisory 502.4, Floor or Ground Surfaces, states, "Access aisles [and accessible parking spaces] are required to be nearly level in all directions to provide a surface for wheelchair transfer to and from vehicles. The exception allows sufficient slope for drainage."

RECOMMENDATION: See items 5 and 6 above. There are several issues with this parking space, access aisle, and curb cut. If these spaces are to be abandoned there is no need to alter them. However, this slope issue will probably exist at other parking spaces along this walkway and will need to be addressed eventually. Repair as required.

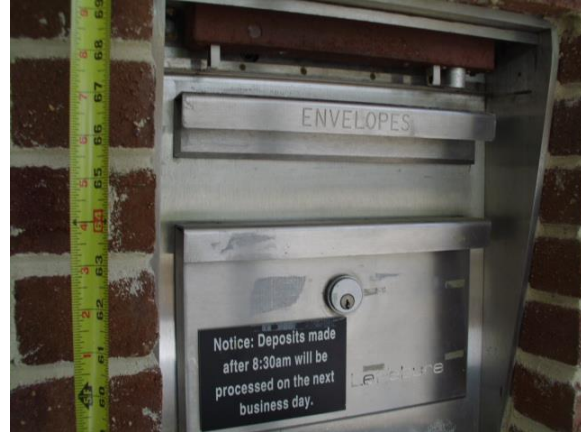
Item 8. The exterior depository in the first drive-through lane is installed more than 48 inches above the driveway. See the photo on the right.

2010 ADA Standard 228.1, [Depositories, Vending Machines, Change Machines, Mail Boxes, and Fuel Dispensers] General, states, “Where provided, at least one of each type of depository, vending machine, change machine, and fuel dispenser shall comply with [Standard] 309. EXCEPTION: Drive-up only depositories shall not be required to comply with [Standard] 309.” In other words, if this installation is considered a drive-up depository only, it does not have to comply with the reach range limits. If this depository is also intended for use by individuals not in a vehicle, then it must comply with Standard 228.1”

2010 ADA Standard 308.3.1, [Reach Ranges, Side Reach] Unobstructed, states, “Where a clear floor or ground space allows a parallel approach to an element and the side reach is unobstructed, the high side reach shall be 48 inches (1220 mm) maximum and the low side reach shall be 15 inches (380 mm) minimum above the finish floor or ground.

RECOMMENDATION: Consider locating the depository within the reach ranges. For disabled individuals who access this depository without a vehicle, the height of the installation will make it difficult to use. This depository may be difficult for any individuals accessing this depository from a sitting position in a vehicle.

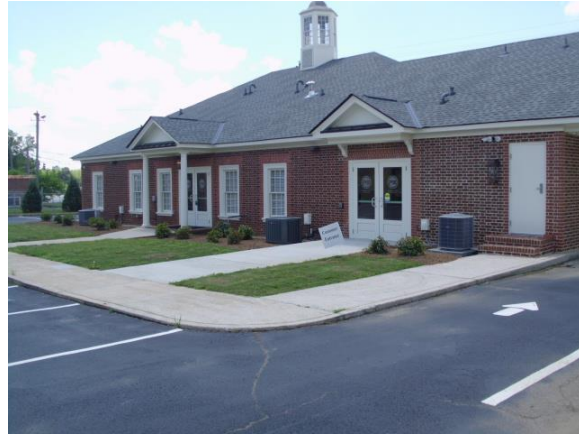
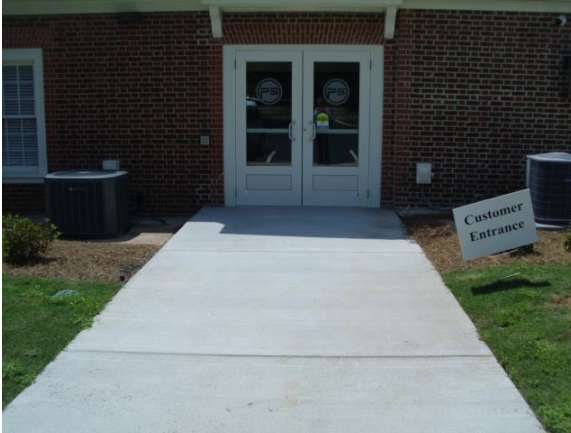
There are four (4) exterior entrance/exit pedestrian door installations located at this PSTC facility. One door is located at the front of the facility and three doors are located at the rear. The automated rear exterior entry/exit door, second from the right at the rear, is the only intended accessible public entry/exit door at the PSTC facility. See the photo on the right for the doors at the rear of the PSTC facility.

Item 9. The automated door marked with a temporary lawn sign for “Customer Entrance” does not have a guide rail on the swing side of the door and the manual side [left side from outside] of the door closes too quickly when released from the 90° open position. See the photo on the left. Looking from the outside, the right door is automated and the left door is manually operated. The automated door is a full-powered

RECOMMENDATION: Install the correct guide rail(s) for the automated swinging door and adjust, repair or replace the manual door closer.

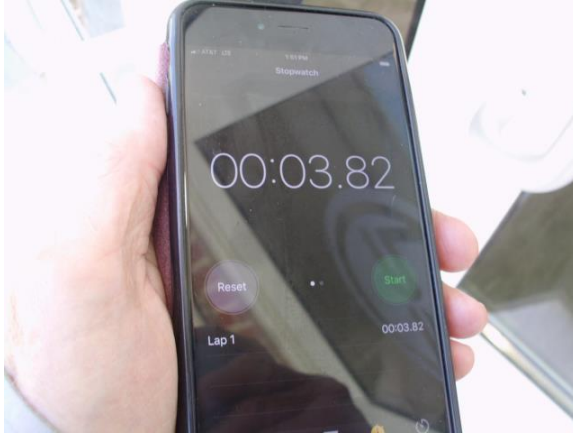
The manually operated door closes too quickly (3.82 seconds). See the photo on the left.

2010 ADA Standard 404.2.8.1, Door Closers and Gate Closers, states, “Door closers and gate closers shall be adjusted so that from an open position of 90 degrees, the time required to move the door to a position of 12 degrees from the latch is 5 seconds minimum.” These doors both closed to a 12 degree position in less than 5 seconds. See the graphic below for a representation of the door closer speed measurement.

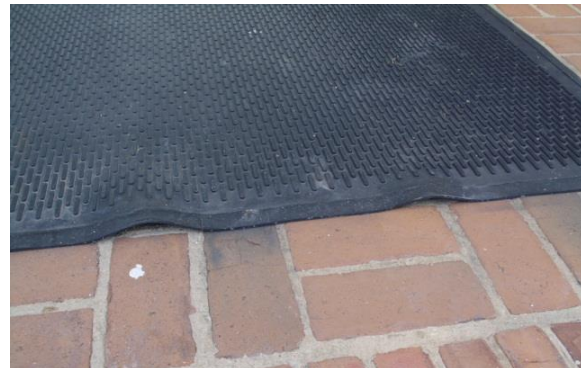
Item 10. Both the front and rear pedestrian entry/exit double doors have automatic closers that allow the doors to close too quickly and, floor mats that have deteriorated and warped edges. The photo on the right is representative of the quick closure rate.

The photo on the right shows a warped floor mat edge.

2010 ADA Standard 302.2, [Floor or Ground Surfaces] Carpet, states, "Carpet or carpet tile shall be securely attached and shall have a firm cushion, pad, or backing or no cushion or pad. Carpet or carpet tile shall have a level loop, textured loop, level cut pile, or level cut/uncut pile texture. Pile height shall be 1/2 inch (13 mm) maximum. Exposed edges of carpet shall be fastened to floor surfaces and shall have trim on the entire length of the exposed edge. Carpet edge trim shall comply with [Standard] 303."

RECOMMENDATION: Repair, adjust or replace the door closers and replace these mats with devices that comply with the ADA Standards. Worn, damaged or warped edges create tripping hazards. These mats are not carpet and therefore do not have to be fastened to floor surfaces and have trim on the entire length of the exposed edge; however, they do provide the service of keeping the floor from being wet (slippery) and should be maintained in good working order and not have worn, damaged or warped edges.

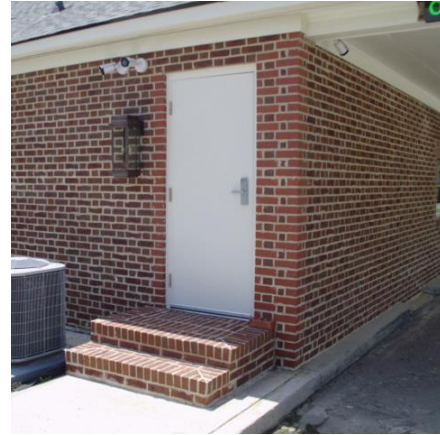
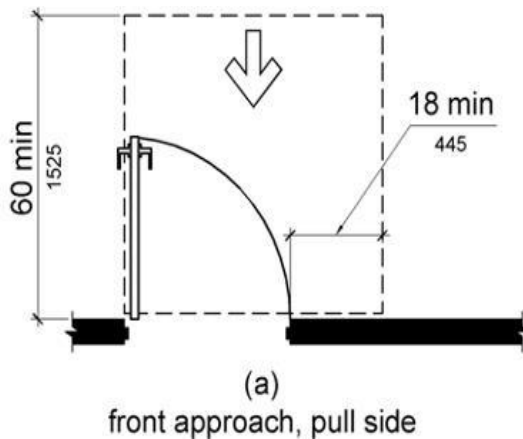
Item 11. The single door located at the rear northeast corner of the facility has several discrepancies including limited maneuvering space at the exterior and interior of the facility, the automated door closer allows the door to close too quickly, and the door opening space is narrow. See the photo on the right. This door swings out to open. This door is for employees only but us not marked as such.

The small size of the step system landing limits the maneuvering space on the outside (pull side) of the door and the interior step system to the 2nd floor compromises the maneuvering space required on the inside (push side) of the door.

2010 ADA Standard 404.2.4.1, [Doors, Doorways, and Gates] Swinging Doors and Gates, “Swinging doors and gates shall have maneuvering clearances complying with Table 404.2.4.1.” Table 404.2.4.1 indicates for a door approached from the forward direction and pulled to open, a space of 18 inches is required parallel to the door on the latch side and 60 inches is required

RECOMMENDATION: Alter the door installation so that maneuvering space is provided on both sides, and adjust, repair, or replace the door closer, and increase the door opening width to at least 32 inches.

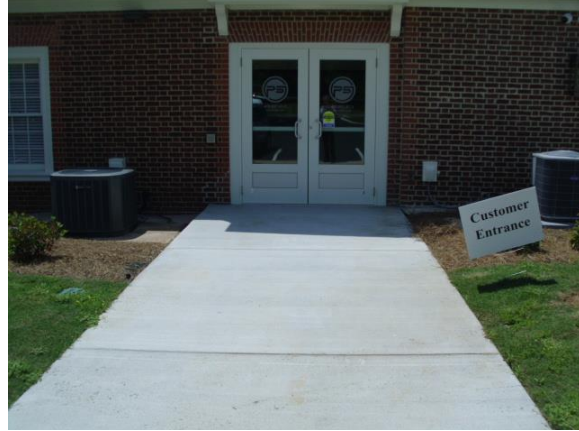
Item 12. There is no signage at the exterior doors indicating which doors are ADA accessible and the front entry door is blocked from access by a sign that reads “Now Open”. PSTC staff indicated that the front and rear manual double doors, and the rear manual single door, are for employees only. Customers are directed to the rear automated double doors for access by a temporary lawn sign that reads “Customer Entrance”. However, there is no sign indicating that the automated door is accessible for disabled individuals. See the photo on the right. All doors can be used to exit the facility.

RECOMMENDATION: Install the ISA sign at doors that will be accessible to the public and directional signs at doors not accessible.

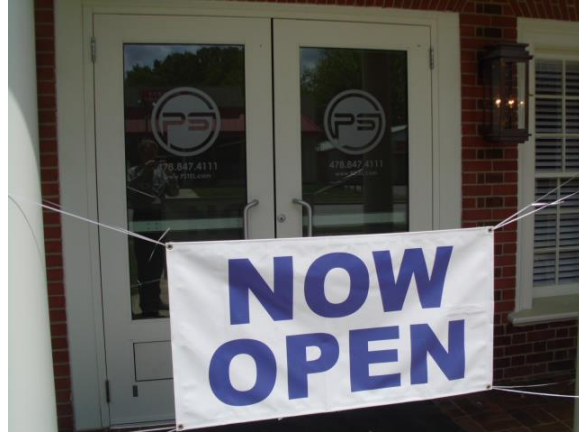
The front entry/exit door is blocked from access on the exterior by a sign that reads “Now Open”, but there is no sign indicating where the customer entrance is located or where an accessible entry is located. See the photo on the right.

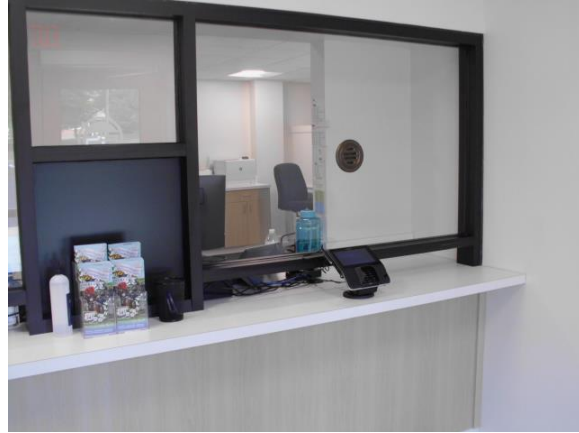
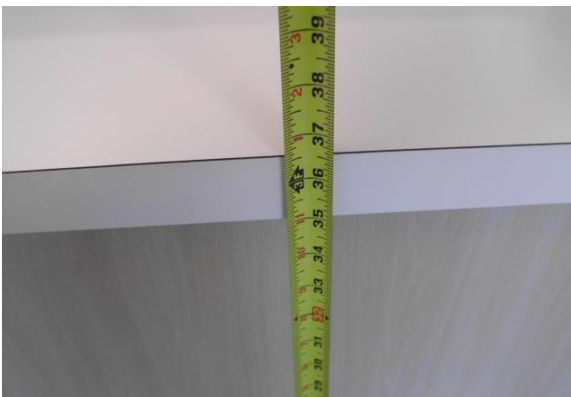
Item 13. The height of the service counter in the customer service lobby is too high above the finished floor at 36.5 or more inches. See the photo on the right. This counter requires a parallel approach from the public side.

The photo on the left shows the height of the counter.

RECOMMENDATION: Alter the counter so that a portion of the counter surface is 36 inches (915 mm) long minimum and 36 inches (915 mm) high maximum above the finish floor. Ensure a compliant clear space is available on the public side of the counter. Note that the employee side of the counter does not have to comply with this ADA Standard; however, continuing this accessible portion of the counter to the employee side will make the employee side of the counter accessible as well. All employee counter tops in the employee work area on the north side of the facility are between 36 – 40 inches above the finished floor.

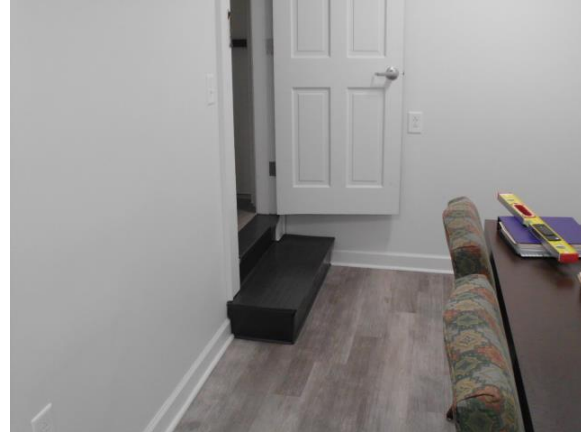
Item 15. The interior door in the employee work area on the north side of the facility that connects to the 2nd floor has compromised maneuvering spaces on both sides of the door and the door opening is too narrow. See the photo on the right.

RECOMMENDATION: Alter the interior door installation so that maneuvering space is provided on both sides of the door and the door opening width is at least 32 inches.

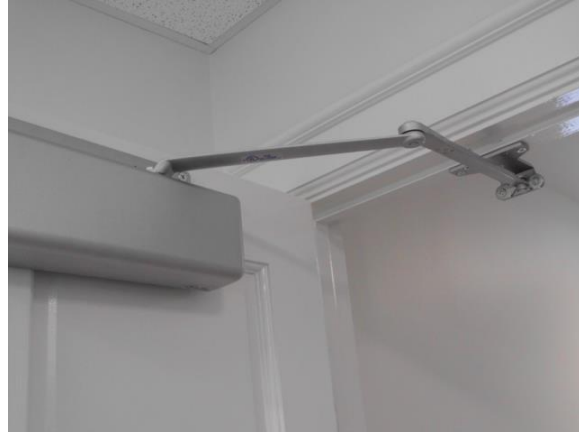
Item 16. The interior doors for the hall where the two toilet rooms are located on the first floor have automated closers that allow the doors to close too quickly and the maneuvering space on the inside/push side of the doors is limited. The photo on the right is representative of a door closer.

RECOMMENDATION: Alter these door installations so that maneuvering space is provided on the push side and adjust, repair or replace the door closers.

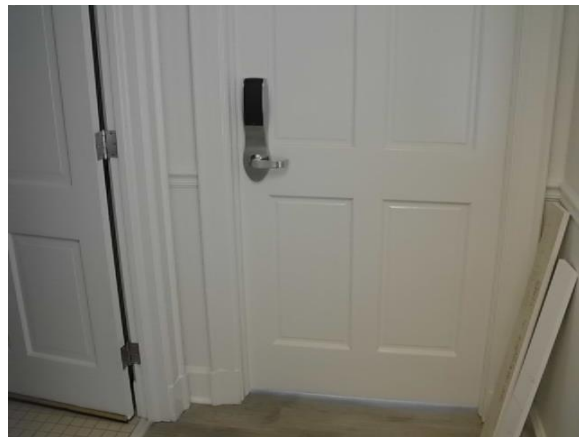
The photo on the right is representative of these doors from the inside/push side of the door. The space to the left/latch side is less than 12 inches parallel to the door on the latch side.

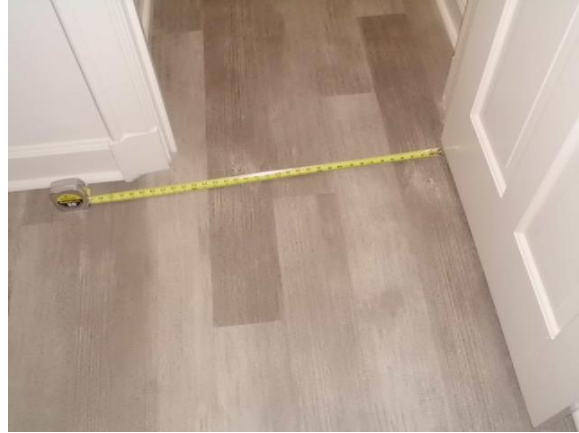
Item 17. Some interior office closet doors and the interior door leading to the stairs for the second floor are too narrow in door opening width.

The photo on the right is representative.

RECOMMENDATION: Increase the door opening widths to at least 32 inches.

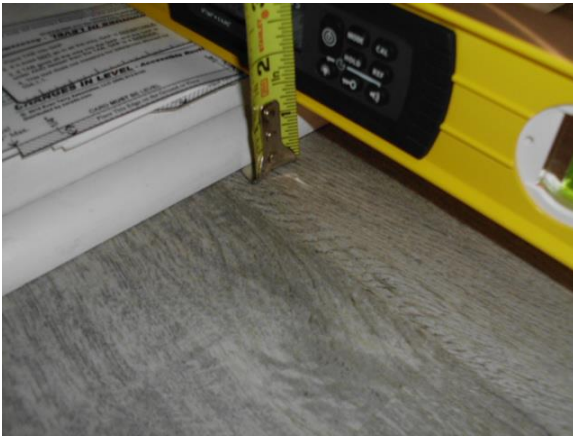
The photo on the left is where a vault door threshold is more than one inch vertical above the finished floor and not beveled not steeper than 1:2 above ¼ inch.

RECOMMENDATION: The doors for these vaults have been removed. There is no need for the thresholds. If possible, remove the thresholds and the objects at the top of the door openings to maximize door opening space and remove the tripping hazards associated with the thresholds.

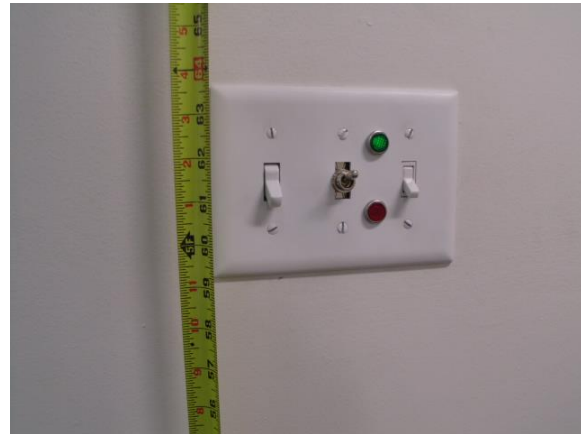
Item 21. Some wall mounted controls such as security panels, thermostats, and wall switches are mounted too high above the finished floor. The photo on the right is representative of a security panel mounted more than 48 inches above the finished floor.

The photo on the right is a wall mounted light switch in the employee area on the north end of the facility.

RECOMMENDATION: Relocate these wall mounted elements to comply with the high side reach and low side reach standards and, if possible, maintain a clear space at each element. This includes the toilet rooms.

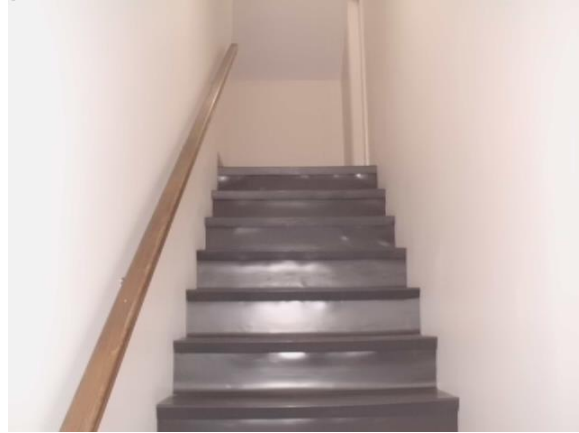
Item 22. The stair system connecting the first and second floors has several discrepancies including the handrail for the stair system has blunt ends and is not high enough above the stair nosings, only one handrail was installed, the handrail cross section is too large, and the step system is steep. The photo on the right is representative of the steps leading up to the second floor.

RECOMMENDATION: If the second floor will have spaces, elements, or activities that employees or non-employees may access, consider providing access for disabled individuals as well. Options could include elevators and platform lifts, although these installations are not required for this facility, based on the current size and use of the facility. See Implementation regulation §36.401, New construction, (d) Elevator exemption (2), and Implementation regulation §36.404, Alterations: Elevator exemption, (a). The graphic below is representative of stair handrail installations.

Handrails are required on both sides and must be continuous within the full length of each stair flight.

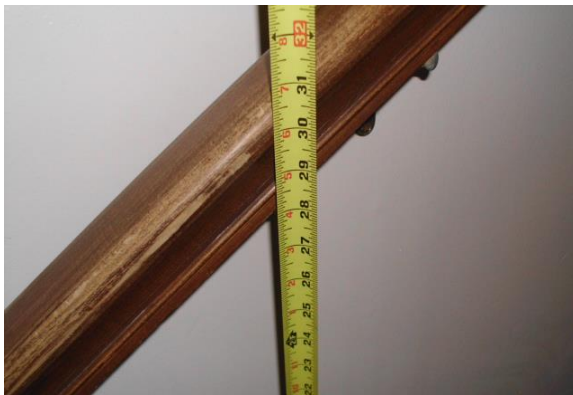
2010 ADA Standard 505.4, [Handrails] Height, states, “Top of gripping surfaces of handrails shall be 34 inches (865 mm) minimum and 38 inches (965 mm) maximum vertically above walking surfaces, stair nosings, and ramp surfaces. Handrails shall be at a consistent height above walking surfaces, stair nosings, and ramp surfaces.” The top of this handrail is only approximately 31 inches above

the nosings. The photo on the left is representative.

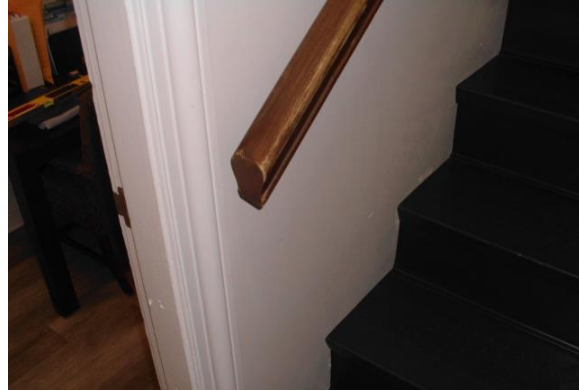
The handrail has a blunt end at the top and bottom of the stair system and the handrail cross section dimension is too large. The photo on the right is representative.

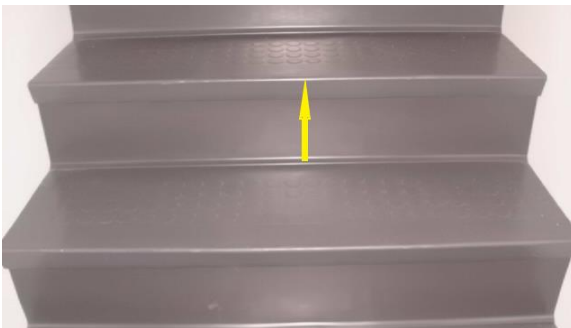
The steps have rise dimensions of approximately 8 inches. The photo on the left is representative.

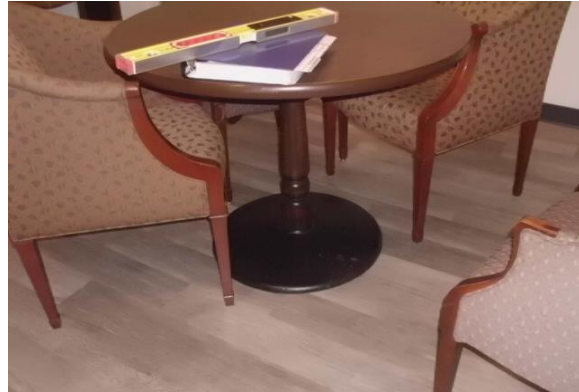
Item 23. The employee break room on the second floor has limited access to the dining table and microwave. See the photo on the right for the dining table.

The space below the table does not have adequate knee and toe clearance. See the photo above. 2010 ADA Standard 902.2, [Dining Surface] Clear Floor or Ground Space, states, "A clear floor space complying with [Standard] 305 positioned for a forward approach shall be provided. Knee and toe clearance complying with [Standard] 306 shall be provided." The graphic on the left is representative of knee and toe clearance.

RECOMMENDATION: Replace and relocate this dining table/chair. Although this table is not a fixed element, replacement is recommended based on the requirements for reasonable accommodations.

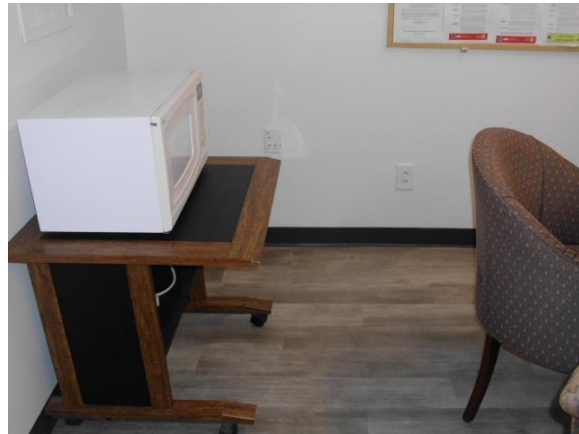
This is a U-shaped kitchenette with only one pedestrian entry/exit point. The space between the microwave table and dining table/chairs is less than 32 inches. See the photo on the right. 2010 ADA Standard 804.2.2, [Kitchens and Kitchenettes] U-Shaped, states, "In U-shaped kitchens enclosed on three contiguous sides, clearance between all opposing base cabinets, counter tops, appliances, or walls within kitchen work areas shall be 60 inches (1525 mm) minimum." Also, accessible routes always require at least 32 inches route width and clear spaces with 30X48 inches of space at all elements.

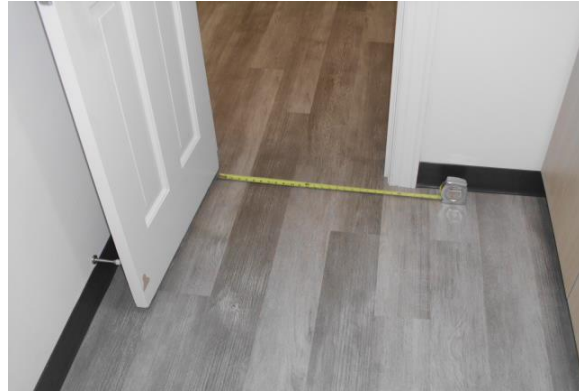
Item 24. The second floor toilet room door opening is too narrow at 22 inches. See the photo on the right.

RECOMMENDATION: Repair or replace the door.

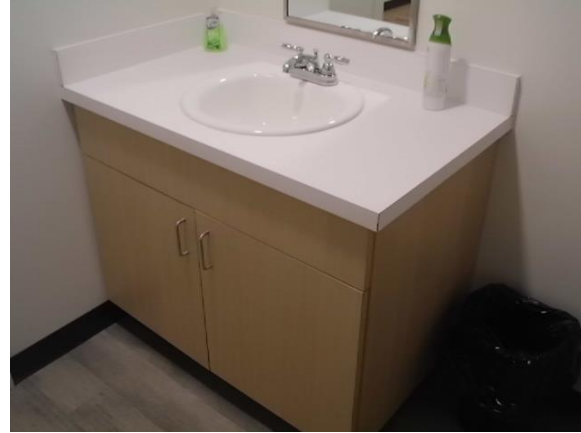
Item 25. The second floor toilet room sink installation does not allow for a forward approach with a clear space and knee and toe clearance below the sink. See the photo on the right.

RECOMMENDATION: Install a sink assembly that complies with the ADA requirements.

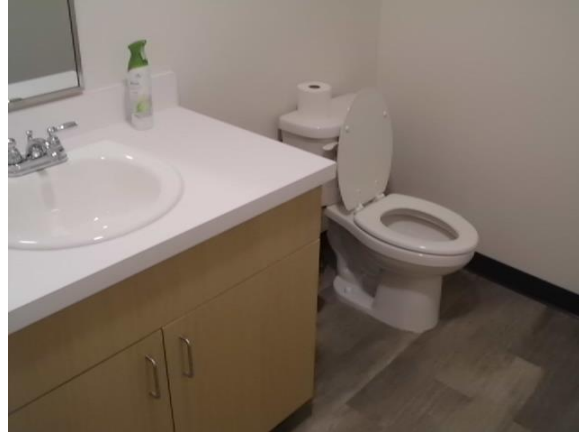
Item 26. The wheelchair transfer space at the toilet and the turning space in the toilet room are too small because of the proximity of the sink/cabinet installation. See the photo on the right.

RECOMMENDATION: Consider replacing the existing sink/cabinet with a design that allows wheelchair transfer space at the toilet and a turning space within the room.

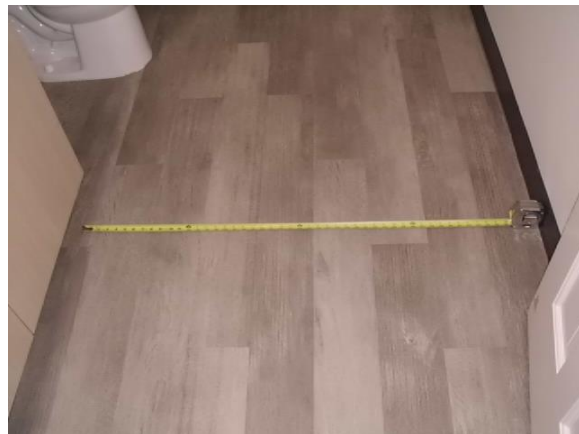
The sink/cabinet installations also limits the turning space required in a toilet room. See the photo on the right.

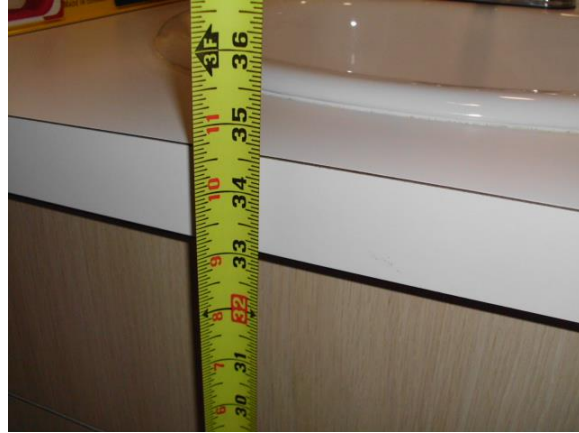
Item 27. In the second floor toilet room the front of the sink/cabinet counter is too high above the finished floor at 34.5 inches. See the photo on the right.

RECOMMENDATION: Replace this sink/cabinet installation with a design that complies with ADA requirements.

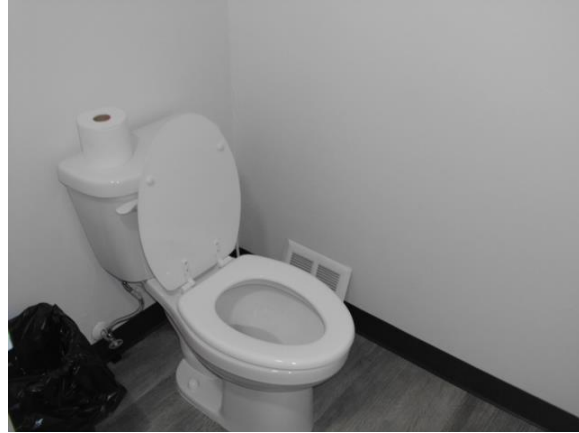
Item 28. No grab bars are installed at the toilet on the 2nd floor. See the photo on the right.

RECOMMENDATION: Install the grab bars on the rear and side walls at the toilet.

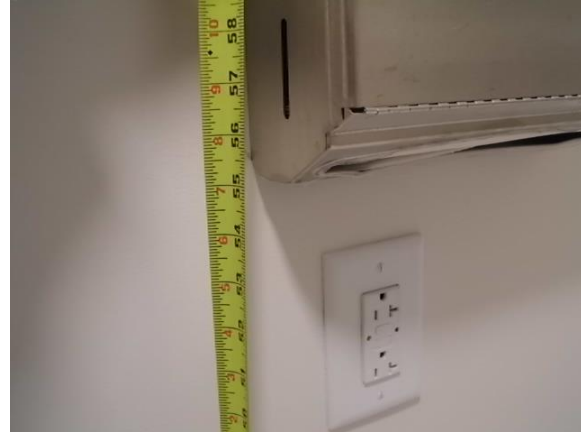
Item 29. The paper towel dispenser is installed too high above the finished floor. See the photo on the right.

RECOMMENDATION: Relocate the paper towel dispenser to within the applicable reach range above the finished floor.

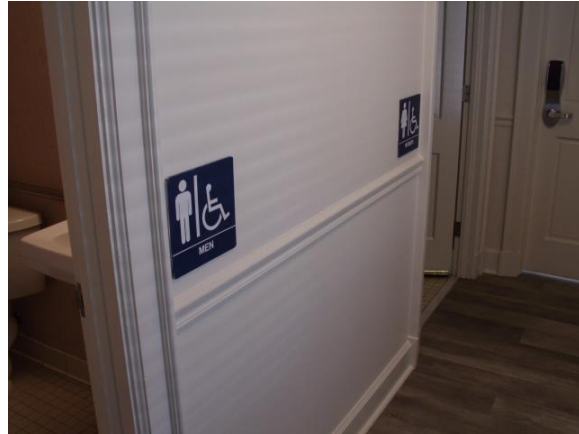
Item 31. The first floor toilet room signs are mounted too close to the floor. See the photo on the right.

RECOMMENDATION: Relocate the signs to comply with the ADA Standards.

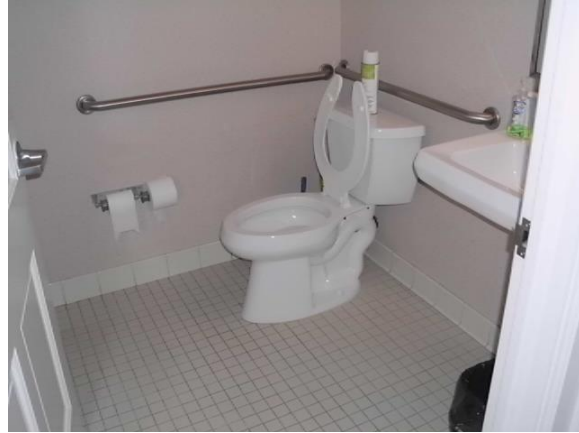
Item 33. In both first floor toilet rooms the wheelchair transfer spaces at the toilets are too small because of the proximity of the sink installation to the toilets. The photo on the right is representative.

RECOMMENDATION: Consider increasing the space in these toilet rooms to create the transfer space at the toilets, or consider combining both toilet rooms into one unisex toilet room.

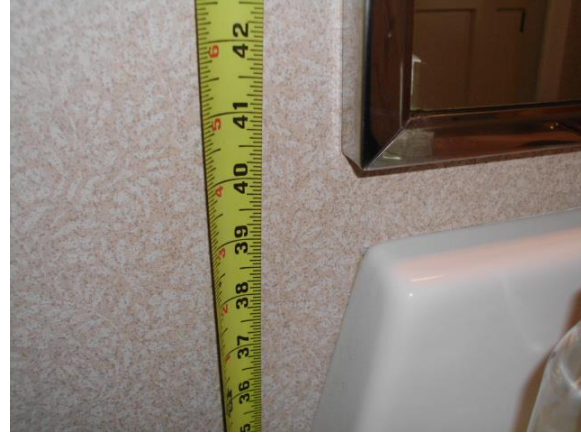
Item 34. The mirror installed above the sink in the first floor Men's toilet room is too small for ADA compliance where the bottom edge of the reflecting surface is too high above the floor. See the photo on the right. The metal frame is not considered a reflecting surface.

2010 ADA Standard 603.3 Mirrors, states, "Mirrors located above lavatories (sinks) or counter tops shall be installed with the bottom edge of the reflecting surface 40 inches (1015 mm) maximum above the finish floor or ground."

RECOMMENDATION: The mirror should be replaced.

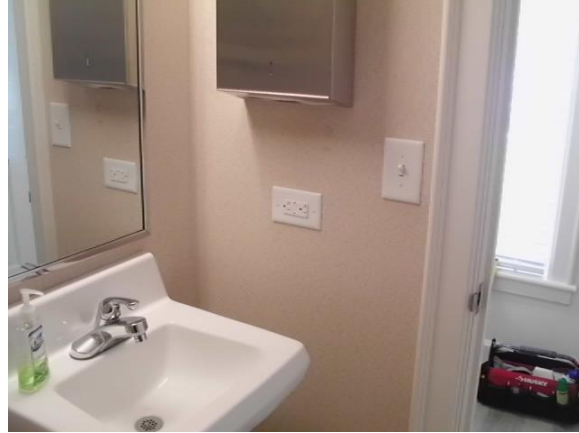
Item 35. In both first floor toilet rooms the paper towel dispensers are installed too high above the finished floor. The photo on the right is representative.

2010 ADA Standard 308.2.2, [Forward Reach] Obstructed High Reach, states, "Where a high forward reach is over an obstruction, the clear floor space shall extend beneath the element for a distance not less than the required reach depth over the obstruction. The high forward reach shall be 48 inches (1220 mm) maximum where the reach depth is 20 inches (510 mm) maximum. Where the reach depth exceeds 20 inches (510 mm), the high forward reach shall be 44 inches (1120 mm) maximum and the reach depth shall be 25 inches (635 mm) maximum." See the graphic below for a representation of this Standard.

RECOMMENDATION: Relocate the paper towel dispensers to within the applicable reach range above the finished floor.

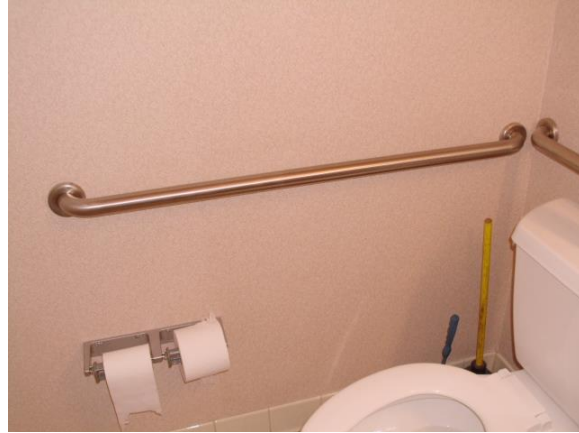
Item 36. In both first floor toilet rooms the side wall grab bars are installed too close to the rear wall.
The photo on the right is representative

2010 ADA Standard 604.5, [Toilet Rooms and Bathing Rooms] Grab Bars, states, "Grab bars for water closets [toilets] shall comply with [Standard] 609. Grab bars shall be provided on the side wall closest to the water closet and on the rear wall."

2010 ADA Standard 604.5.1, [Grab Bar] Side Wall, states, "The side wall grab bar shall be 42 inches (1065 mm) long minimum, located 12 inches (305 mm) maximum from the rear wall and extending 54 inches (1370 mm) minimum from the rear wall. See the graphic on the right for a representation of this standard. The side wall grab bars in these toilet rooms are installed only a few inches from the rear wall, which prevents the side wall grab bars from extending 54 inches (1370 mm) minimum from the rear wall.

RECOMMENDATION: Install the grab bars on the side walls at the toilets correctly according to the ADA Standards.

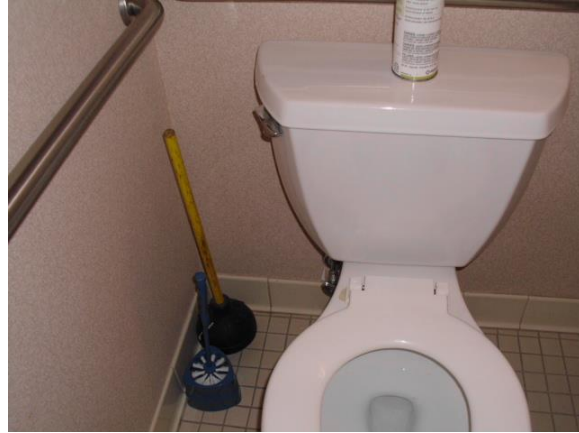
Item 37. In the first floor Men's toilet room the toilet flush handle is not located on the open side of the toilet. See the photo on the right.

2010 ADA Standard 604.6, [Water Closets and Toilet Compartments] Flush Controls, states, "Flush controls shall be hand operated or automatic. Hand operated flush controls shall comply with [Standard] 309. Flush controls shall be located on the open side of the water closet except in ambulatory accessible compartments complying with [Standard] 604.8.2." The graphic below is representative of this Standard.

RECOMMENDATION: Replace or alter the toilet installation to place the flush handle on the open side of the toilet in the first floor Men's toilet room.

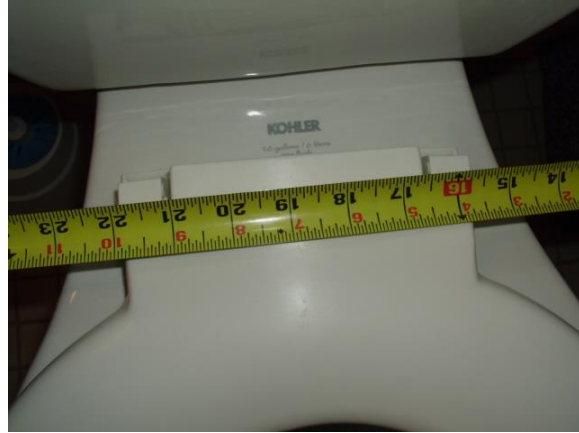
Item 38. In the first floor Women's toilet room the toilet is installed slightly too far from the side wall. See the photo on the right.

2010 ADA Standard 604.2, [Water Closets and Toilet Compartments] Location, "The water closet shall be positioned with a wall or partition to the rear and to one side. The centerline of the water closet shall be 16 inches (405 mm) minimum to 18 inches (455 mm) maximum from the side wall or partition, except that the water closet shall be 17 inches (430 mm) minimum and 19 inches (485 mm) maximum from the side wall or partition in the ambulatory accessible toilet compartment specified in 604.8.2. Water closets shall be arranged for a left-hand or right-hand approach." The graphic on the left is representative of this Standard.

RECOMMENDATION: Consider relocating the toilet to within ADA Standards from the side wall.

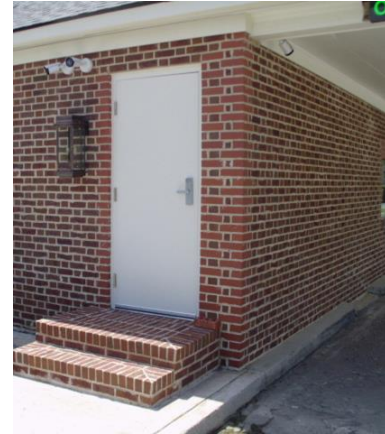
Item 39. The exterior door near the rear northeast corner of the facility is narrow and has step installations that will interfere with the egress route through this door for individuals with limited mobility. See the photo on the right.

According to the United States Access Board Standards Guide, the International Building Code (IBC) requires at least two means of egress from all spaces and buildings with few exceptions. Some spaces and buildings are allowed to have one means of egress if the travel distance to an exit is short and the occupant load is low. For example, a business occupancy with no more than 30 occupants and a maximum exit access travel distance of 75 feet is permitted to have a single means of egress. More than two means of egress are required where the occupant load is 500 or more (at least 3) and 1,000 or more (at least 4). The IBC requirements for accessible means of egress apply to new construction. Accessible means of egress are not required to be added in alterations to existing facilities. See the diagram below for a representation of egress components.

RECOMMENDATION: Consider altering this door at the rear northeast corner to provide an accessible emergency egress route. This door could be critical in an emergency for egress of individuals in the north side employee work area and 2nd floor break room.
